Report of the

# PRESIDENTIAL COMMISSION

*on the Space Shuttle  
Challenger Accident*

June 6, 1986

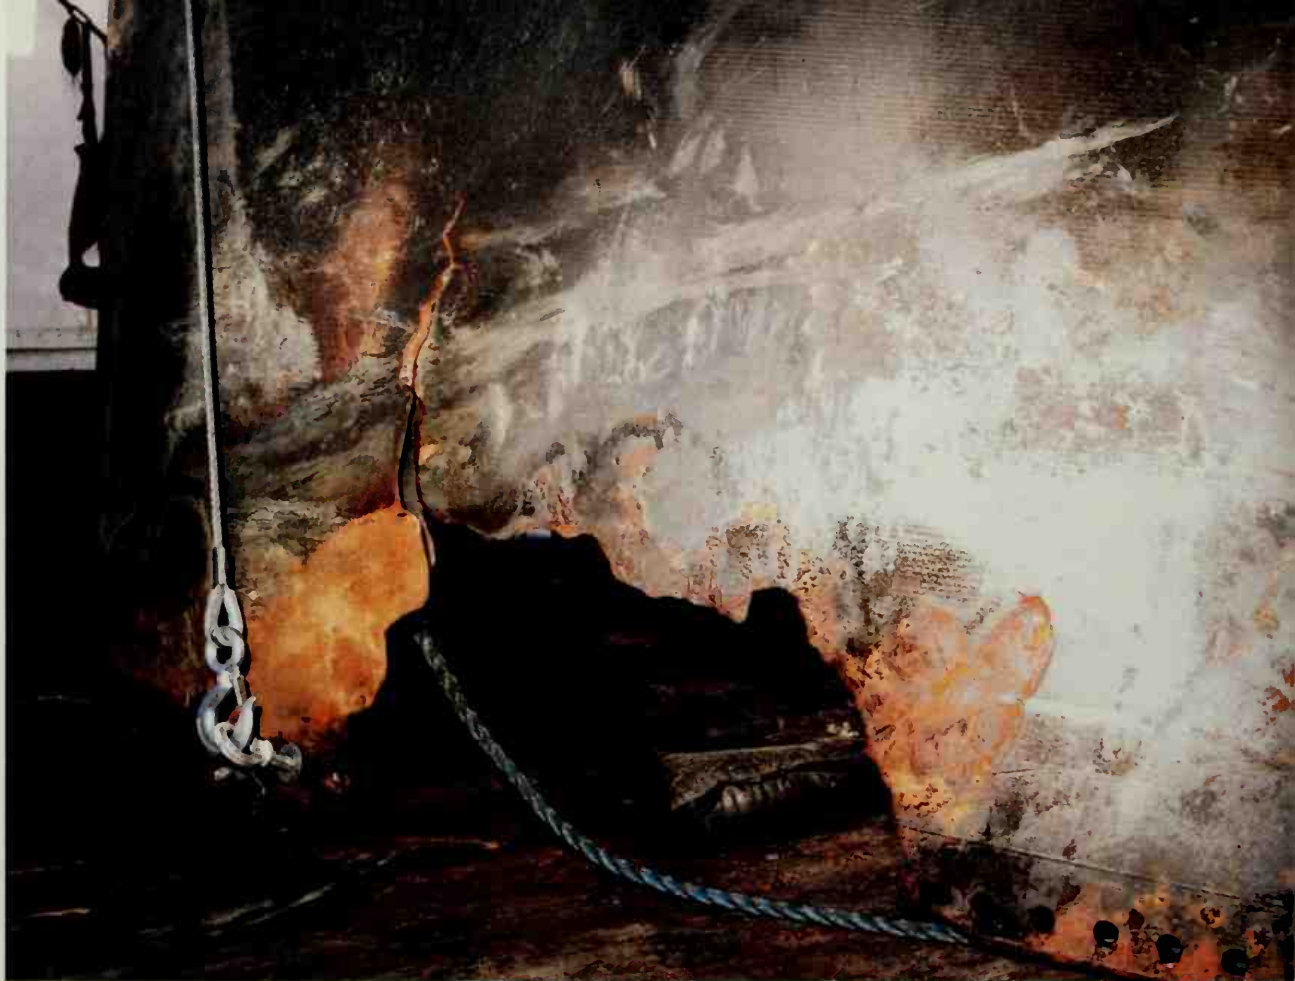
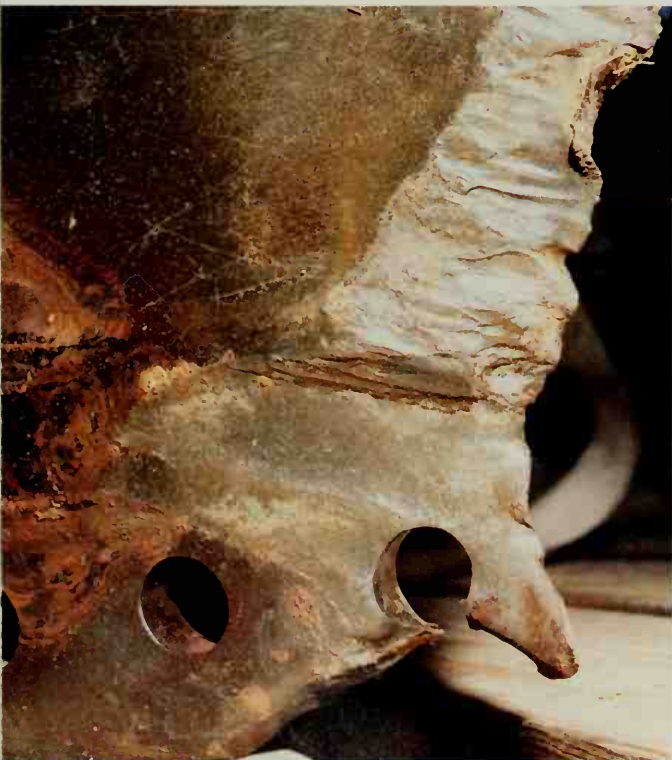
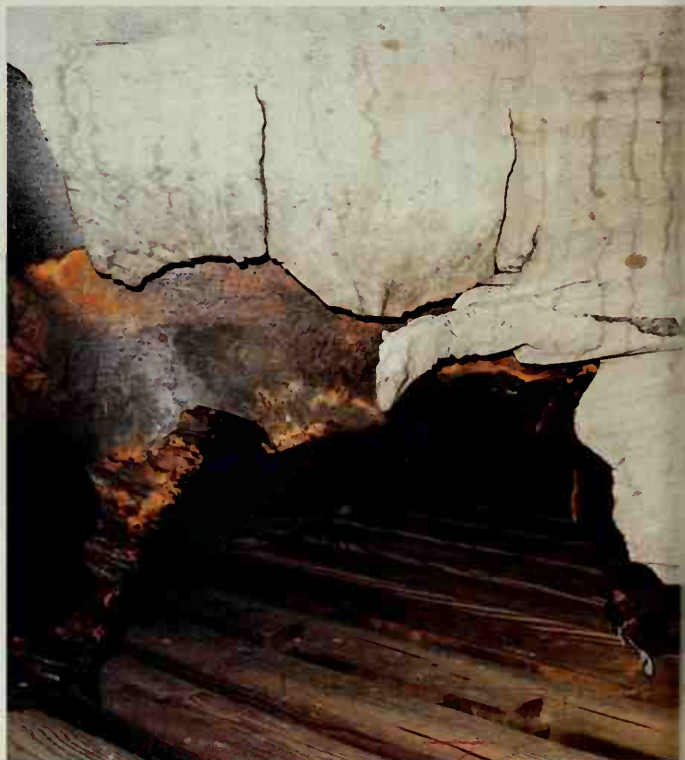
Examined at Kennedy Space Center after their recovery from the ocean, these fragments show the extent of burn through the right hand booster's aft field joint. On the left page are sections of the aft center motor segment above the joint. On the right page are sections (inverted) of the aft motor segment showing burn-hole below the joint (bracket). Except for the interior views on lower left, the camera is viewing the parts from outside the casing.

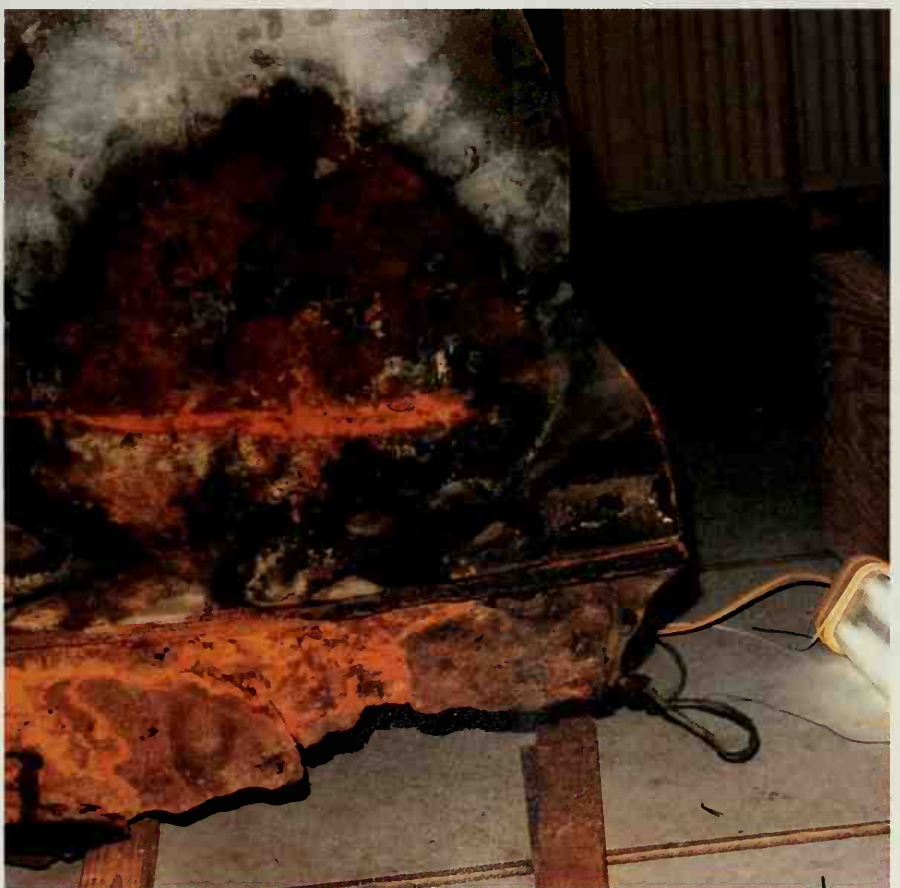
M

At upper left is the aft segment burn viewed from inside the casing; the lower photo is a closeup of the same section. The latter photo shows a hole (arrow) where the flame plume may have burned through the casing from the outside. At right is a composite view of the burn above and below the aft field joint.

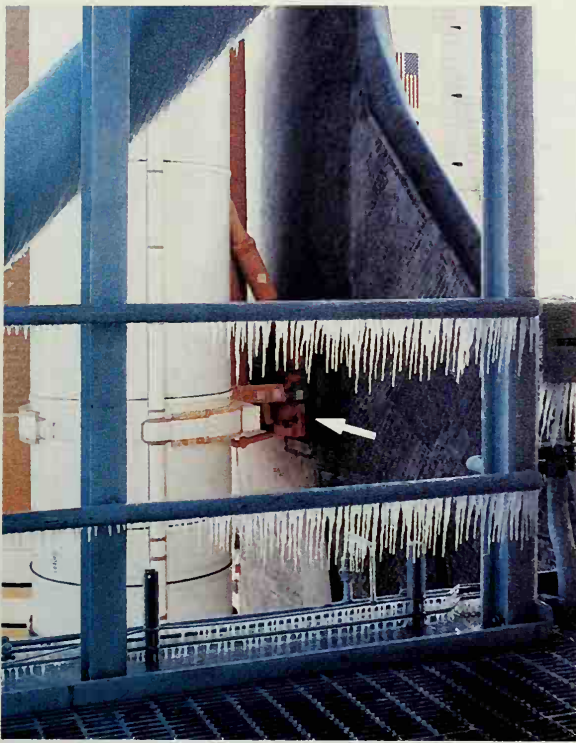
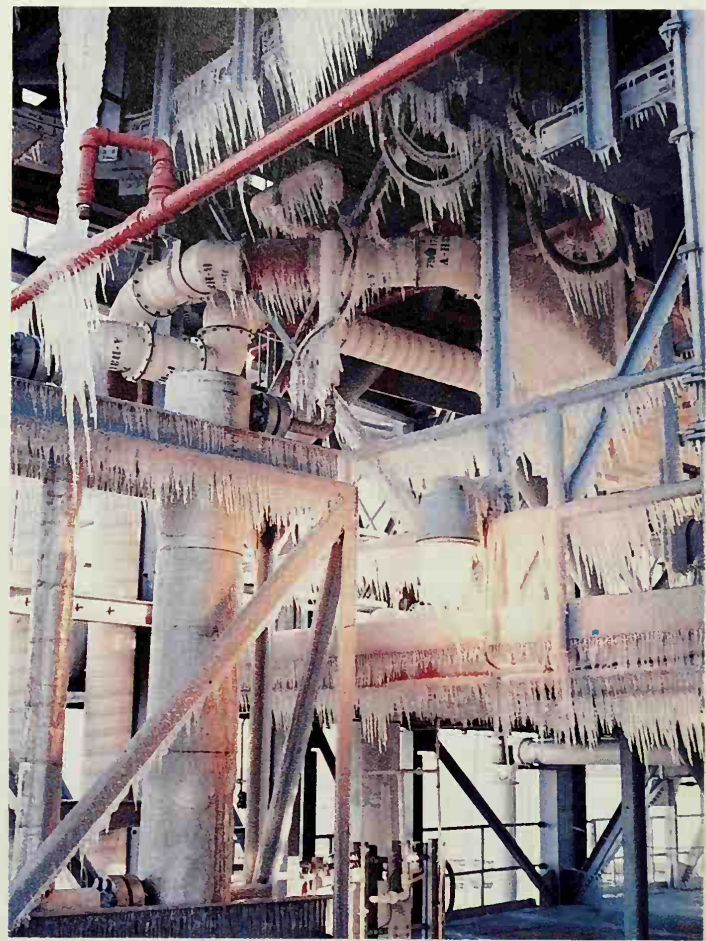
Above, foot long icicles on a lower level of the Fixed Service Structure frame the attachment point where the Orbiter is attached to the external tank (arrow). Icing was even more extensive at upper levels of the service structure (upper right and below). At right below is a ground communications box (not used during launch) rendered inoperable by heavy ice.

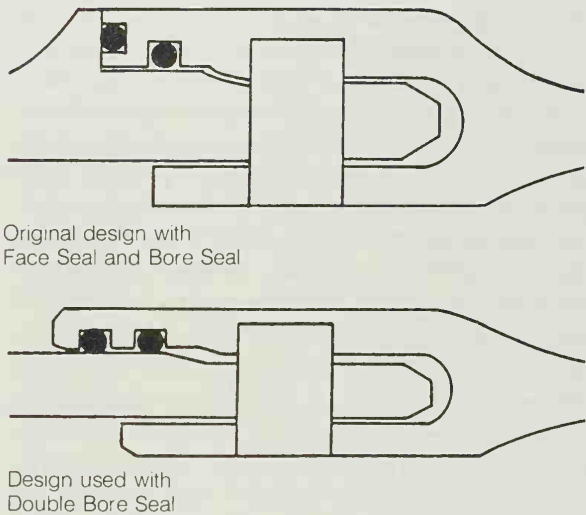
Figure 1

The initial Thiokol design proposal was changed before the production motors were manufactured. Originally, the joint seal design incorporated both a face seal and a bore seal.<sup>16</sup> (Figure 1.) However, the motor that was eventually used had double bore O-rings. The original bore seal/face seal design was chosen because it was anticipated that it “provides [better] redundancy over a double bore ring seal since each is controlled by different manufacturing tolerances, and each responds differently during joint assembly.”<sup>17</sup> Because the early design incorporated tolerances similar to the Titan and it also incorporated a face seal, Thiokol believed it possessed “complete, redundant seal capability.”<sup>18</sup>

Nevertheless, as the Solid Rocket Motor program progressed, Thiokol—with NASA’s concurrence—dropped the face/bore seal design for one using a double bore seal (Figure 1). NASA engineers at Marshall said the original design would have required tapered pins to maintain necessary tolerances and assure enough “squeeze” on the face-sealing O-ring.<sup>19</sup> However, design analysis determined that motor ignition would create tension loads on the joint sufficient to cause the tapered pins to pop out. Solving that would have meant designing some type of pin-retainers. Moreover, the rocket assembly was much easier with the dual bore seals. Because inspections and tests had to be conducted on the Solid Rocket Motor stack, horizontal assembly was required. Thiokol engineer, Howard McIntosh, described this in a Commission interview on April 2, 1986:

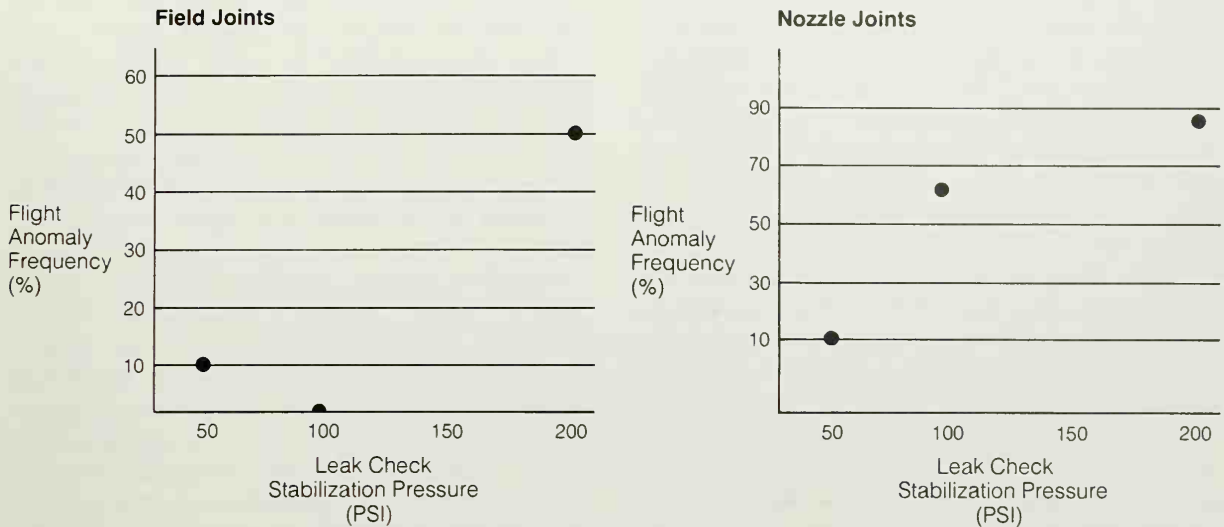
Graphs depict flight anomaly frequency for both field and nozzle joint of solid motors for a variety of leak check pressures Figure 3

This hypothesis that O-ring erosion is related to putty blow holes is substantiated by the leak check history (Figure 3). Prior to January, 1984, and STS 41-B, when the leak check pressure was

The trends of flight anomalies in relation to leak check stabilization pressure are illustrated for the field joint and the nozzle joint in Figure 3, on page 133. While the data point concerning the 100 pound per square inch field joint leak check is not conclusive since it is based on only two flights, the trend is apparent.

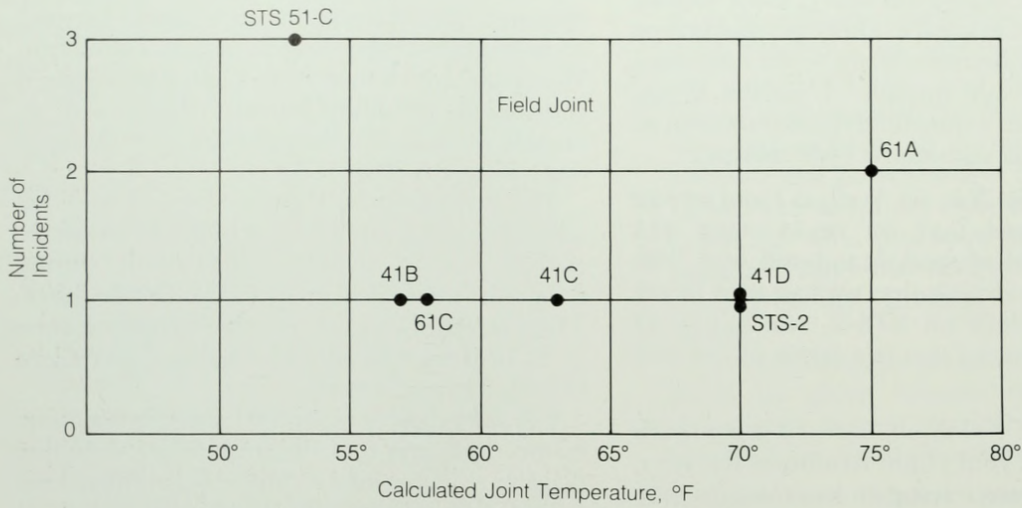
cy of occurrence based on all flights (Figure 6). In such a comparison, there is nothing irregular in the distribution of O-ring "distress" over the spectrum of joint temperatures at launch between 53 degrees Fahrenheit and 75 degrees Fahrenheit. When the entire history of flight experience is considered, including "normal" flights with no erosion or blow-by, the comparison is substantially different (Figure 7).

Figure 6  
Plot of flights with incidents of O-ring thermal distress as function of temperature

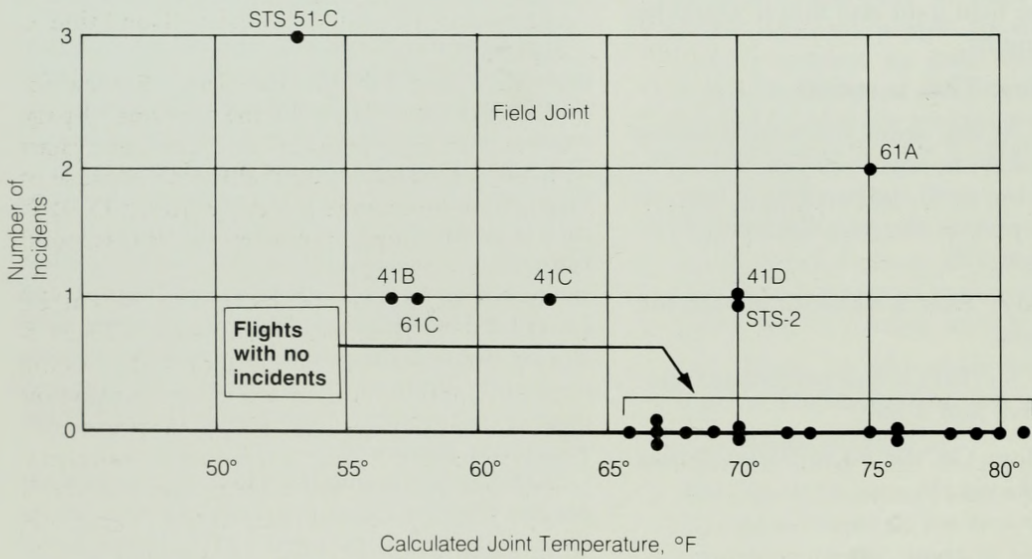
Figure 7  
Plot of flights with and without incidents of O-ring thermal distress

NOTE: Thermal distress defined as O-ring erosion, blow-by, or excessive heating

6. A careful analysis of the flight history of O-ring performance would have revealed the correlation of O-ring damage and low temperature. Neither NASA nor Thiokol carried out such an analysis; consequently, they were unprepared to properly evaluate the risks of launching the 51-L mission in conditions more extreme than they had encountered before. ■
